October 12, 2016

Project: Pre-construction assessment for property re-development at 15511 NE 90th Street, Redmond, WA. Parcel number 022505-9224.

Objectives: Evaluate health of existing trees and establish criteria for the preservation of those to be retained.

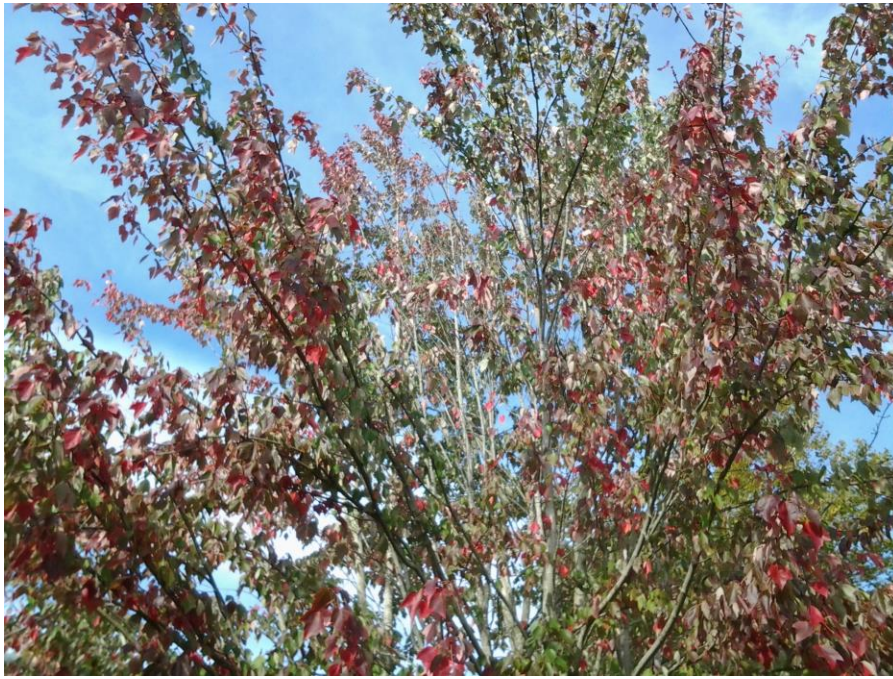
- 5) Red Maple 11" DSH, 32' tall, 18' spread standing 45' east of the NW corner of the property. Tree is in weak condition with surface cracking at its base indicative of cankers (Figure 6). Center stems are dying and dead (Figure 7).
- 50) Moraine locust 11.5" DSH, 38' tall, 12' spread standing 15' west of the #49 tree. It is in fair condition.
- 51) Recently missing Moraine locust

Figure 6. Photo showing dead and dying center of #5 Red maple.

Even though the #5 Red maple is in weak condition it will become the only City tree near the proposed new building. Therefore it merits some discussion in regards to the impact it will or will not sustain from the redevelopment process. With an 11 inch DSH, the maple has an 11 foot radial CRZ. The north side of the proposed building will be less than 10' from the southern edge of this tree's root radius according to the plans shown in Figure 2. Assuming that in the worst case the excavation for the new north side foundation will come as near as 9' to the base of the tree, and knowing that from Figure 29 the Structural Root Plate for an 11" DSH tree is given as 6.5', it can be expected that building the new foundation should not interfere with its SRP.

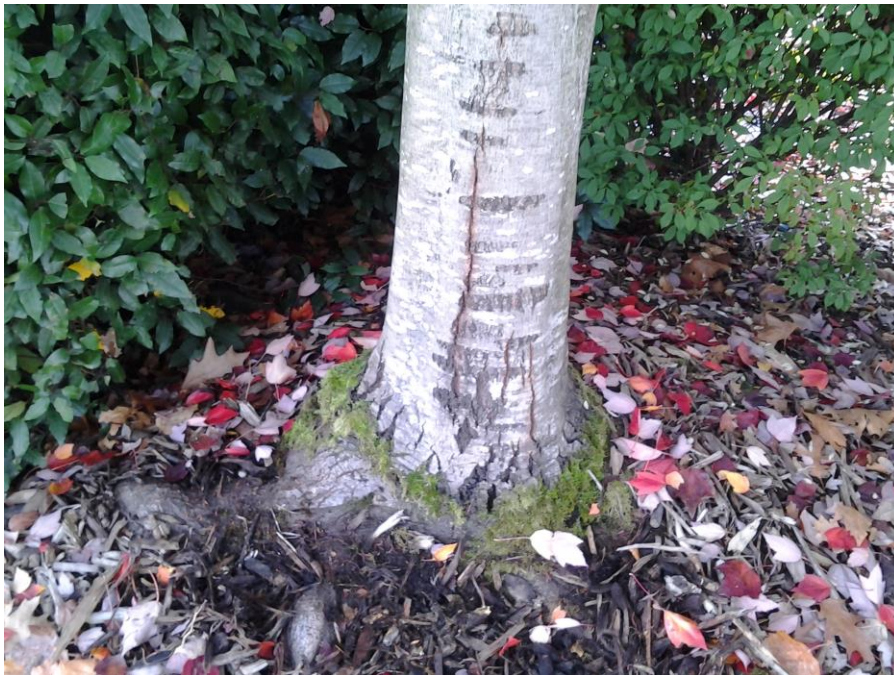
Figure 7. Photo showing cracks at base of #5 Red maple.

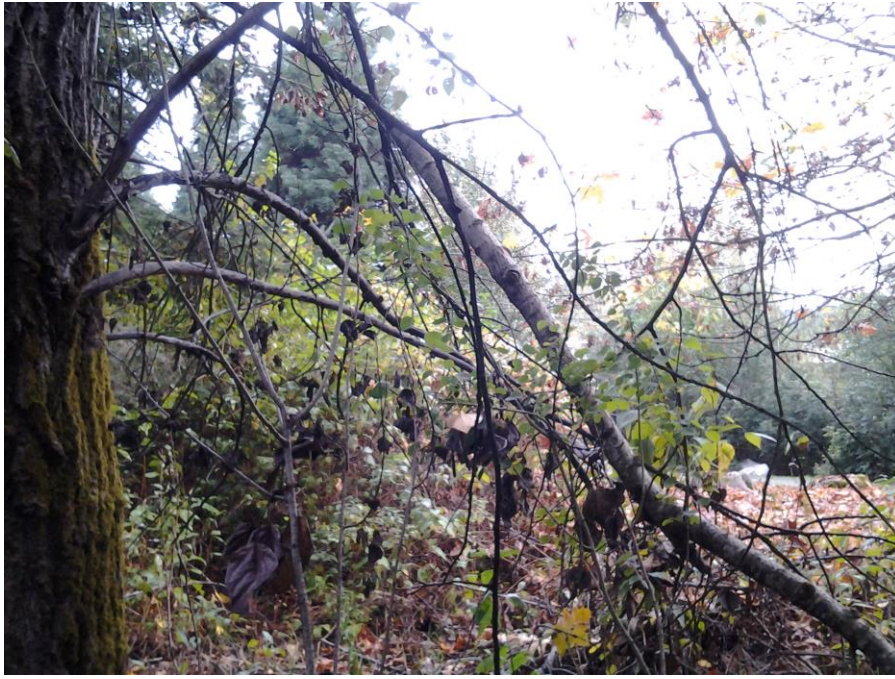
- 17) Cottonwood 34" DSH, 85' tall, 22' spread in poor condition. The tree has reasonable color and unbalanced canopy. It has average new growth but lower density, large caliper die back, and large caliper breakage (Figure 8). There is a cavity with decay on the south side of the base which was probed to 18" (Figure 9). There are multiple decay points in the scaffolds. The tree is 25' east of the center of the building.

The #17 and #30 cottonwoods along with the #19 and #20 aspens are significantly compromised due to the extent of basal decay present and have **probable likelihoods of catastrophic failure**. Each has a **high likelihood** of hitting the existing building. The cottonwoods are tall enough to strike cars in the proposed parking area and the aspens will reach the driveway portion and center trail shown in Figure 2. This categorizes them as **likely** to fail and impact now or after redevelopment. The results of any of these trees striking the current building or vehicles and pedestrians in the future would be **severe** for the cottonwoods and **significant** for the aspen making each a **high risk** tree.

Figure 8. Photo of recent large caliper breakage from the #17 cottonwood.

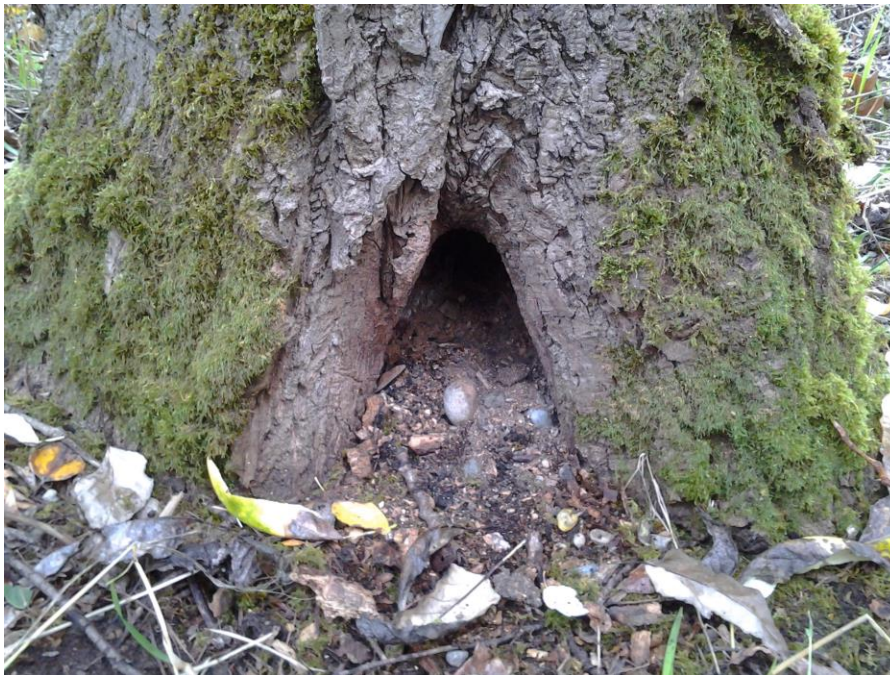
Figure 9. Cavity at base of the #17 cottonwood.

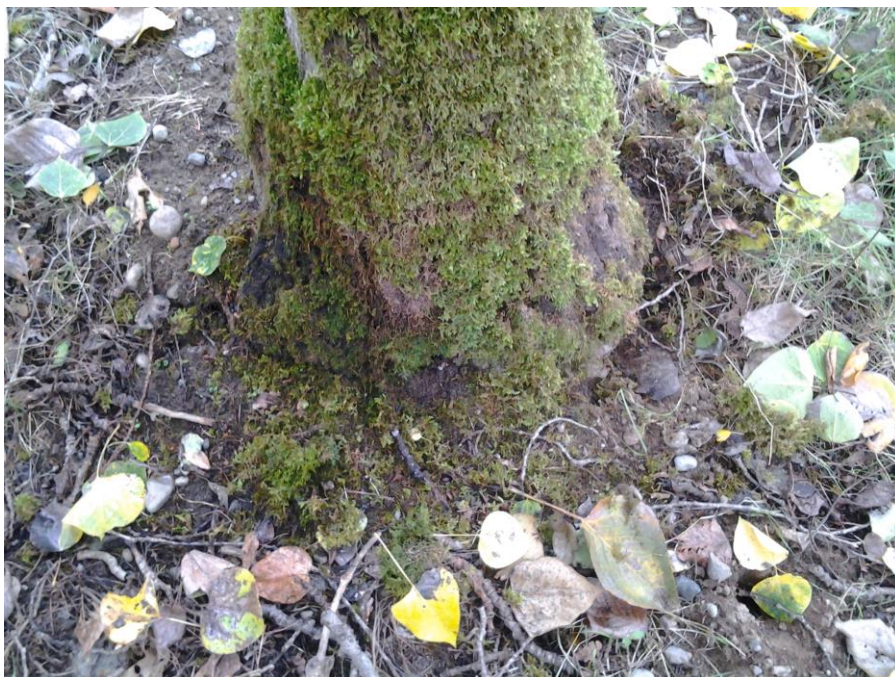
Figure 10. Base of the #19 aspen showing fungal bodies and little to no flair.

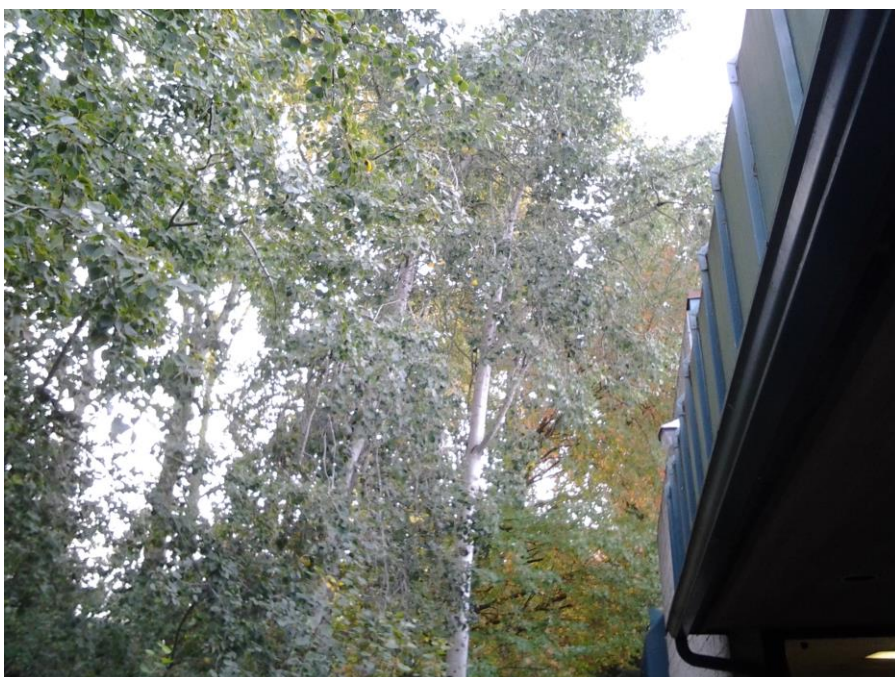
- 19) Aspen 10" DSH, 42' tall, 6' spread standing 6' south of center, 12' east of the building. Tree is in weak condition with below average new growth, poor color, and there is slight ground shift when the stem is pushed on by hand. Its base has little flair and there are fungal bodies indicative of black rot (Figure 10). The trunk bends to the west from the 10' mark and the canopy over shadows the building (Figure 11).

Figure 11. Photo of #19 aspen looking to the south. Note bend to the west.

There are six trees onsite within the secondary impact zone. The #10 and #12 firs; the #19 and #20 aspens; the #23 maple; and the #40 cottonwood are all along the edge of the demolition area. The #19 and #20 aspens are in poor condition, were condemned in the Risk Assessment section, and will be removed. Likewise the #23 maple as it is in poor condition and has unnecessary risk components.

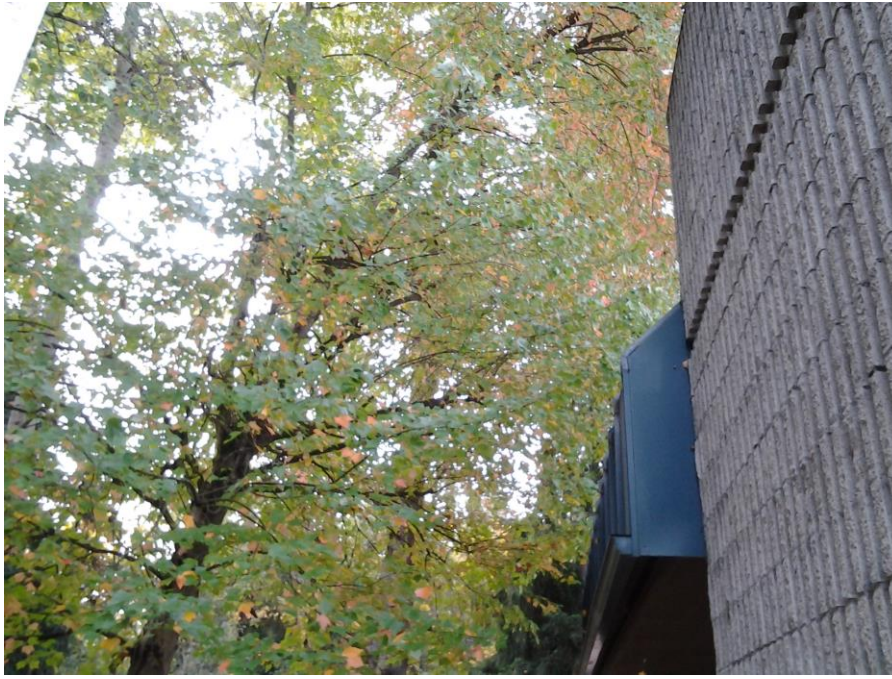
- 23) Red Maple 14" DSH, 36' tall, 16' spread in poor structural condition. The tree has decent color and new growth. The majority of its canopy extends to the west and hangs over the building as shown in Figure 12. It stands 12' east and 8' north of the SE corner of the building. There is a 5" caliper atrophied spar at the 9' mark on the east face (Figure 13). The tree leans increasingly to the west as it grows.

The trees with a propensity for stem failure include the #23 maple, the #39 and #40 cottonwoods, and the #43 and #44 aspens. Each has a **probable likelihood of failure** because of significant structural weaknesses in their formation. While the maple and aspens have **high likelihoods** of hitting the existing building they would only have **medium likelihoods** of striking a car or pedestrian in the proposed parking area. So they are **likely to fail and impact** now but only **somewhat likely to fail and impact** in the redeveloped scenario. The consequences could be **significant** in either case making each tree a **high current risk** but only a **moderate risk in the future**.

Figure 12. Photo of #23 Red maple looking to the south and showing the pronounced western canopy growth and the stem lean.

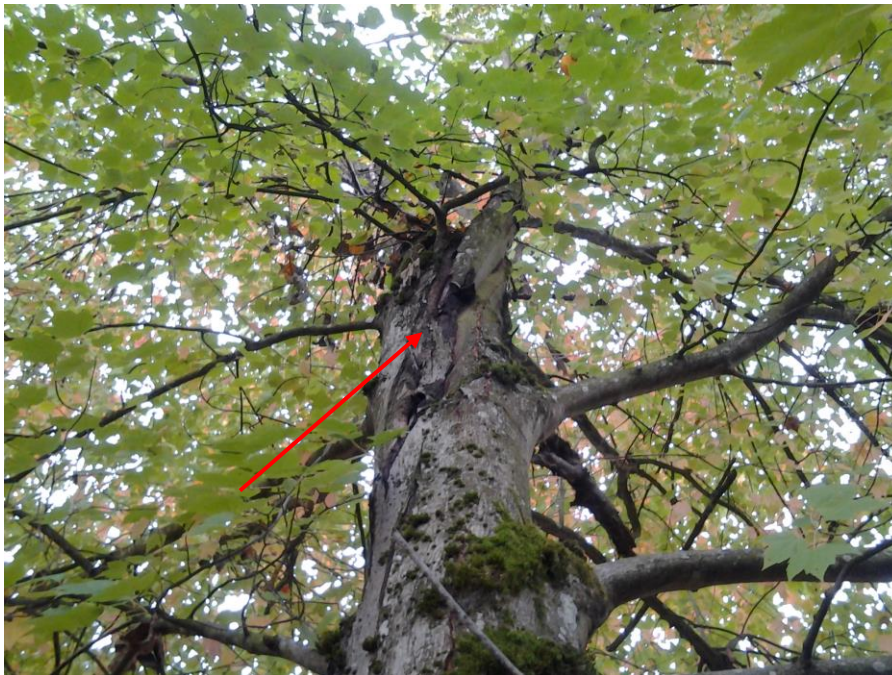
Figure 13. Photo of the #23 maple looking up and to the west. The image shows the atrophied stub (red arrow) which creates a significant weak point.

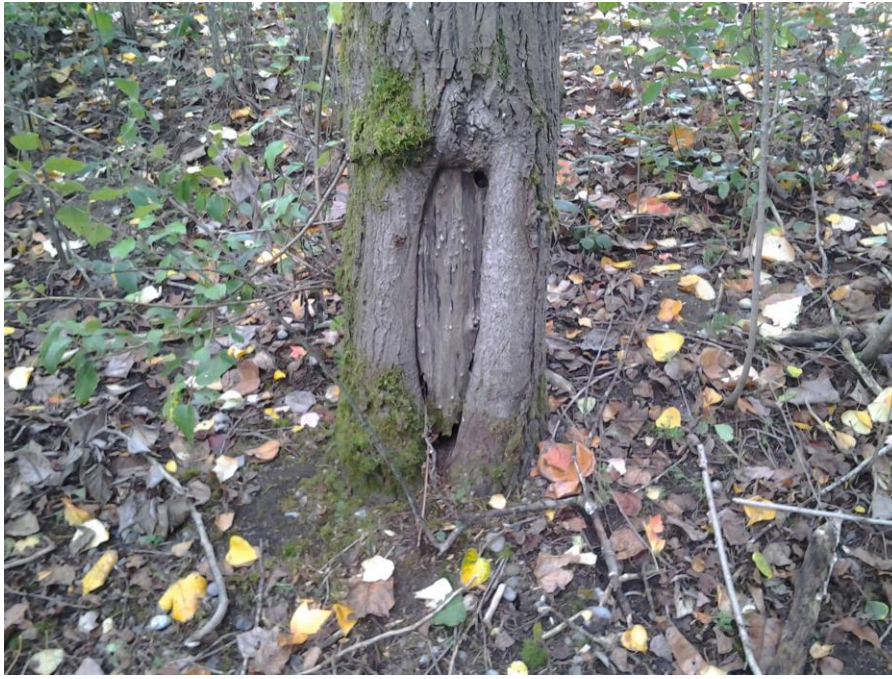
- 30) Cottonwood tree 16" DSH, 48' tall, 12' spread all to the west side. It is in poor condition with an open wound at the NE quadrant of the base which shows advanced decay (Figure 14). Its entire canopy extends to the west. The tree stands 20' due east of the SE corner of the building.

Figure 14. Photo of base of #30 cottonwood looking to the SW. The decay present behind the wound extends at least 8" deep.

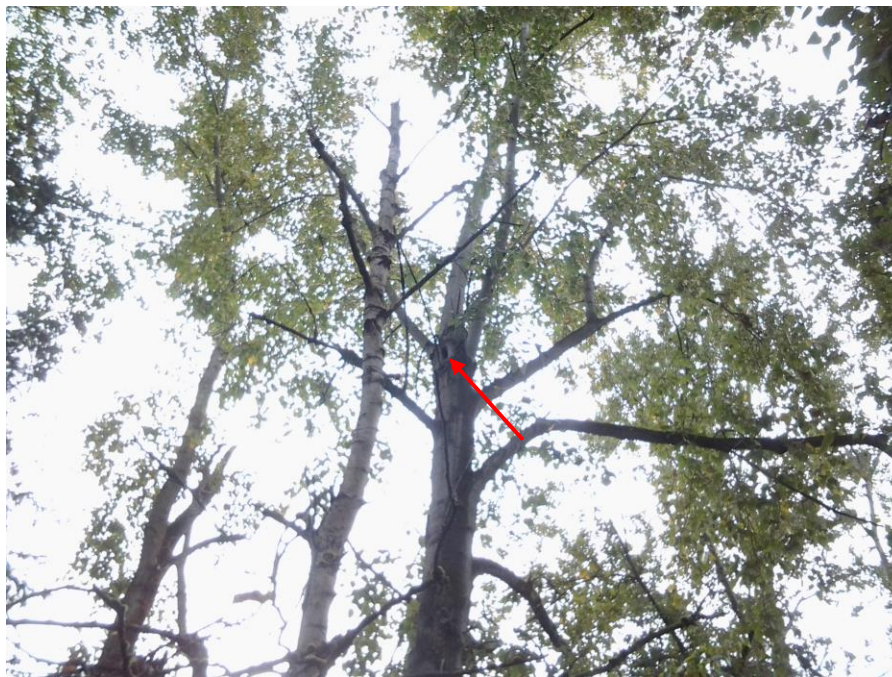
- 39) Cottonwood tree 27" DSH, 90' tall, 22' spread mostly to the south side. There is a significant decay point at the 40' mark on the north face of the mainstem (Figure 15). Majority of the canopy extends to the SW and hangs over the handicap parking at the east end of the drive. The color is fair and there is average new growth. It stands 18' SSE of the #33 fir.

The #39 and #40 cottonwoods over shadow the handicap parking for the property to the south and the shared driveway and have **high likelihoods** of hitting either. This makes them **likely to fail and impact** now and in the future. The consequences could be **severe** resulting in each tree having a **high risk** category.

Figure 15. Photo of the #39 cottonwood looking up and to the SE. The large caliper decay point is indicated by the red arrow. The #38 dead birch is shown slightly to left of center.

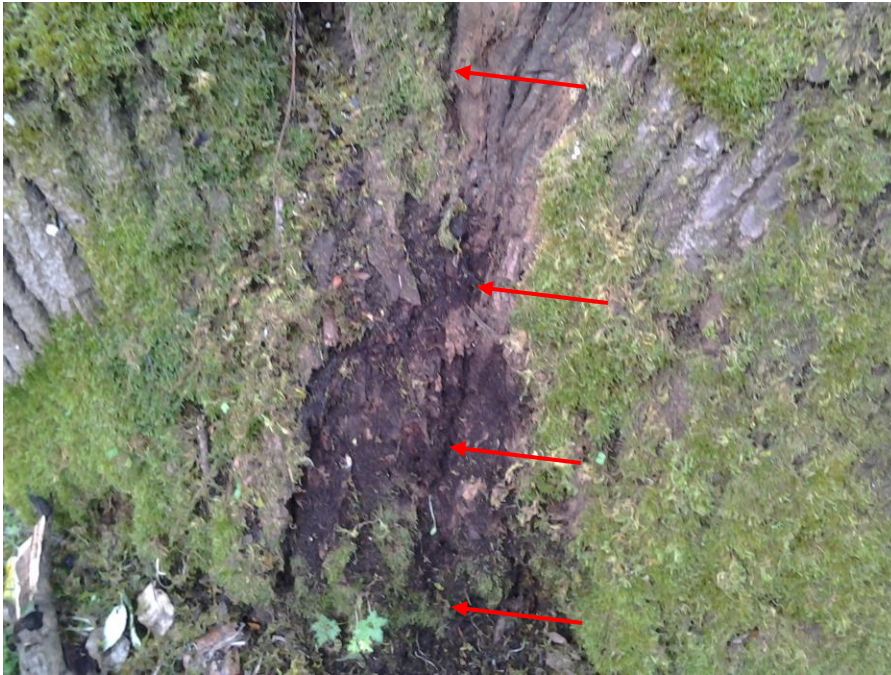
- 40) Three stem cottonwood located at the east end of the entrance drive 15' east of the curb line and 30' south of the SE corner of the building. South stem is 24" DSH, 45' tall, 30' spread to the SW over the handicap parking. It has compromised attachment to the center stem (Figure 16) which is 27" DSH, 95' tall, 30' spread all to the west. The north stem is 14" DSH, 45' tall, 18' spread and it leans to the NW nearly crossing over the SE corner of the existing building. There is surface evidence of a beam fracture east to west in the center stem (Figures 17 and 18). There are large caliper breaks throughout the canopy. The tree's roots are beginning to lift the asphalt in multiple places. Because of the number and severity of the structural faults this tree will be classified as being in poor health according to the City of Redmond's definitions.

Figure 16. Photo of base of #40 cottonwood looking to the west. The line down the center of the image (red arrows) shows the active fracture plane between the south and center stems.

The #40 cottonwood stands in the SE corner of the property and may be shared by the 8950 154th Avenue property to the south and/or the King County buffer land. This tree was listed as being in weak condition and therefore is a non-significant tree according to the City of Redmond code. It was assessed as being a high risk to persons and property and should be removed. At minimum the 14" north side stem will be removed and the canopy on the center stem will have to be pruned back from the parking area and drive for the Hopelink site.

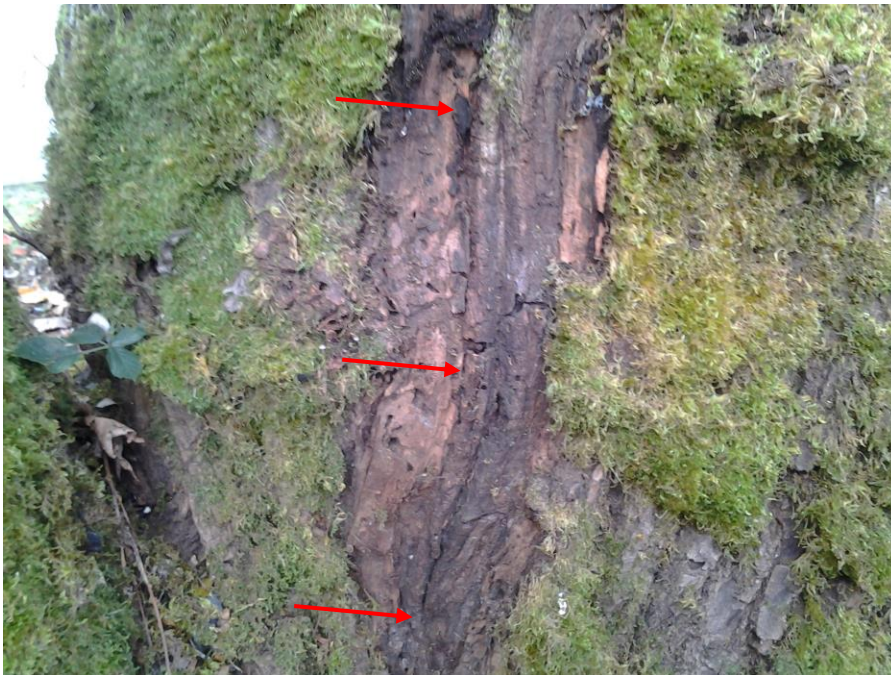
Figure 17. Photo of base of center stem of #40 cottonwood looking to the west. The line pointed out with the red arrows is highly indicative of a beam fracture as it is matched on the opposite side as shown in Figure 18 below.

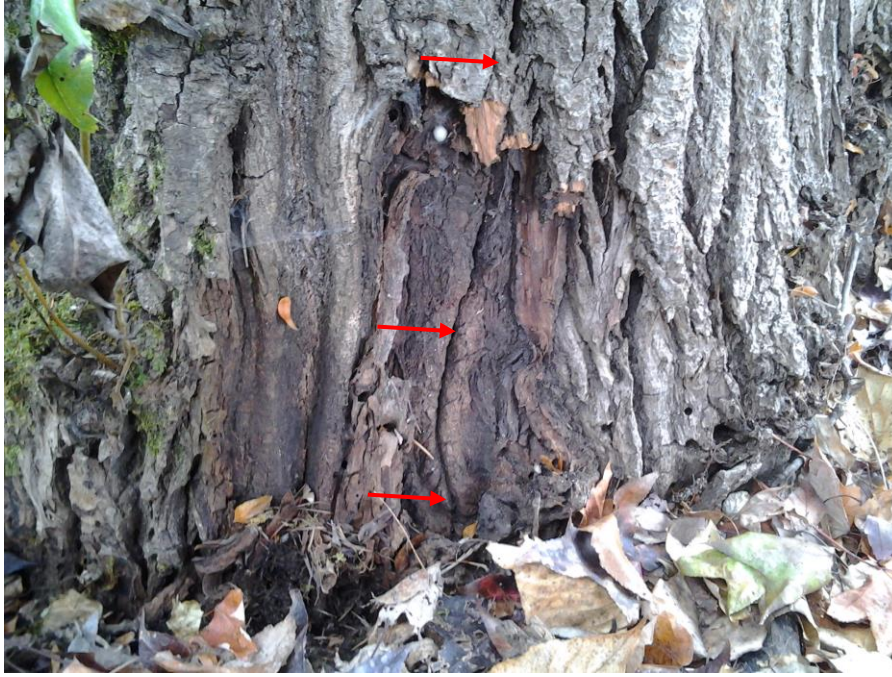
Figure 18. Photo of base of center stem of the #40 cottonwood looking to the east. The red arrow show the seam which is opposite of the one shown in Figure 17.

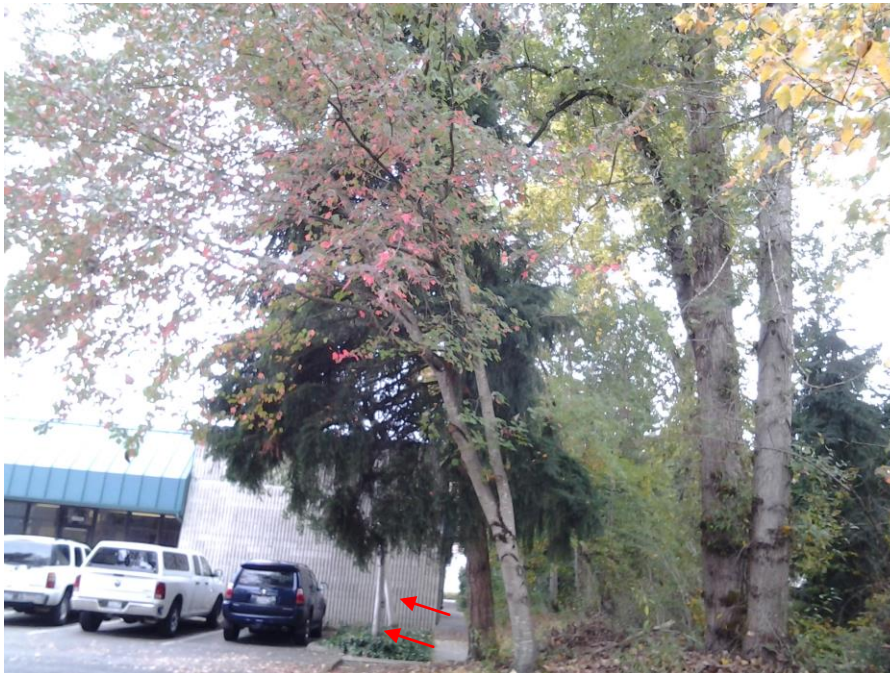
- 41) Red Maple 11.5" DSH, 28' tall, 14' spread standing slightly west and under the #40 cottonwood. Its canopy grows all to the west over the drive (Figure 19). It is in fair condition.

Figure 19. Photo of #41 Red maple looking to the north and showing its western reaching canopy. The lower stems of #40 tree are shown at the right of the image. The #42 fir stand just behind the maple and the bases of the #43 and #44 aspens can be seen just in front of the building (red arrows).

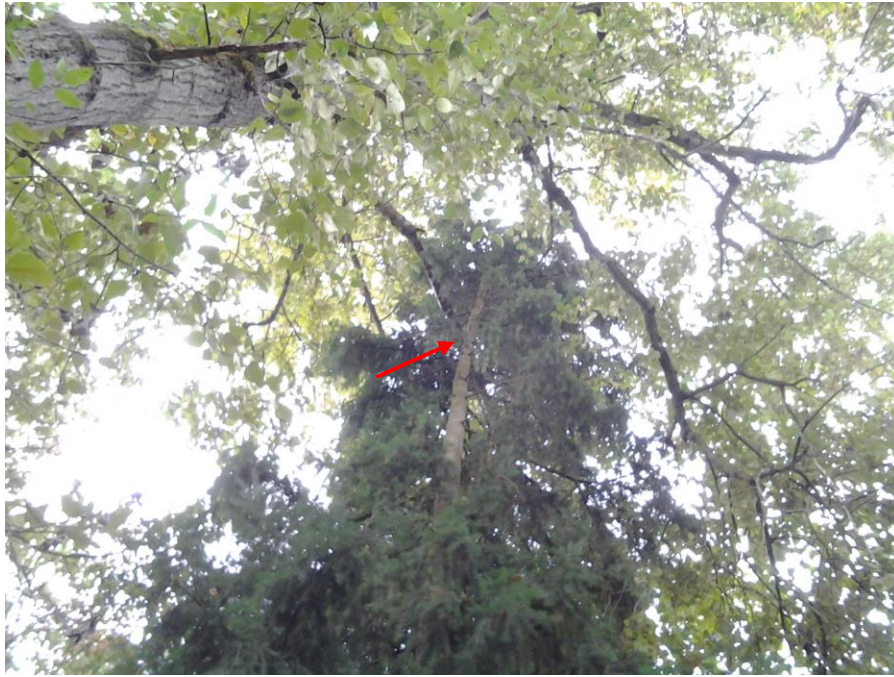
- 42) Douglas Fir with 15.5" DSH, 60' tall in fair condition. Majority of the canopy is above the half way mark. The color is decent and there is good new growth most of which extends to the west. It is subordinated to the #40 cottonwood and stands even with the #41 maple. Some of the larger tree's limbs cross through the fir's canopy and one rubs against the stem as shown in Figure 20.

Figure 20. Photo of #42 fir looking up and to the SW. Note large limb from the #40 cottonwood crossing against its stem (red arrow).

The #42 fir is a more difficult case as the demolition will come to within 6' of the base of the tree but only at an acute angle. The limit of incursion is the same as for the #10 tree, 7' so the onsite arborist will have to make sure that there is no occurrence of root damage inside that limit.

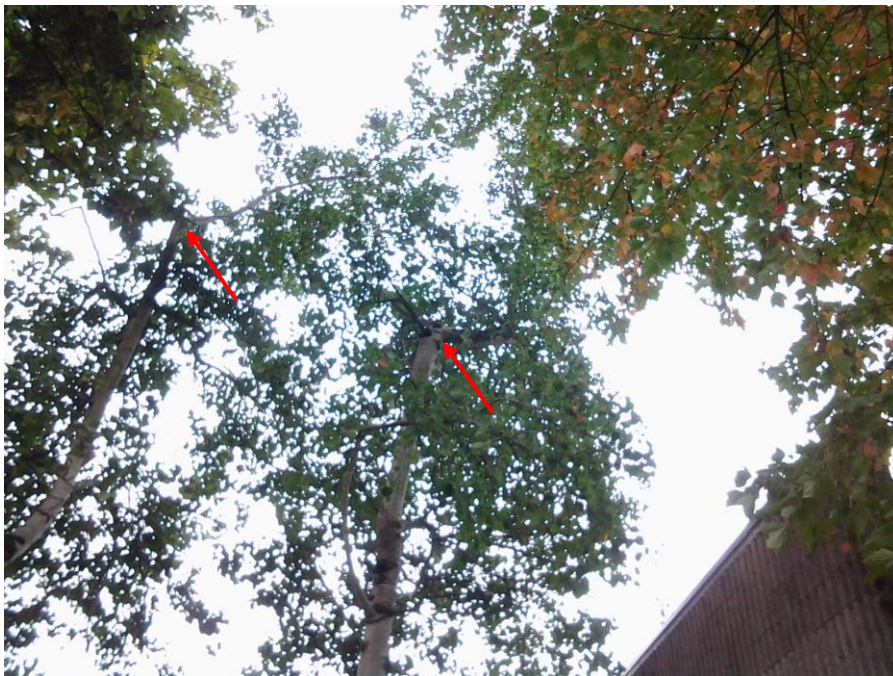
- 44) Aspen 8.5" DSH, 30' tall, 8' spread in poor condition. The tree has reasonable color and below average new growth. It stands 6' south of the SE corner of the east building. It has a structural fault near the 20' mark where the trunk turns 90 degrees to the north and extends over the corner of the building (Figure 21).

Figure 21. Photo of the #43 and #44 aspens looking up and to the west. Note the significant structural faults (red arrows) present in the upper canopies of both trees.

The #43 and #44 aspens stand in the primary impact zone at the SE corner. They are in poor condition, do not count as viable trees, and will be removed.

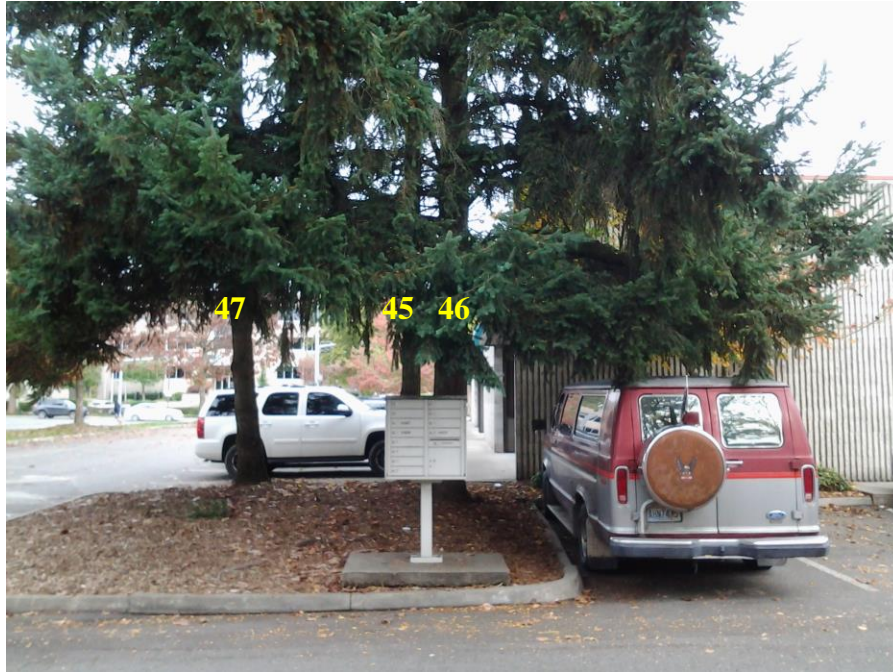
- 46) Douglas Fir 15" DSH, 60' tall in fair condition. It stands 9' SSW of the SW corner next to the #45 tree (see Figure 22).
- 47) Douglas Fir 12" DSH, 35' tall in fair condition. It stands 6' W of the #46 fir.

Figure 22. Photo showing the proximity of the #45, #46, and #47 firs to the existing building and their orientation to each other (labeled in red). These three will be removed as they are within the new construction bounds.

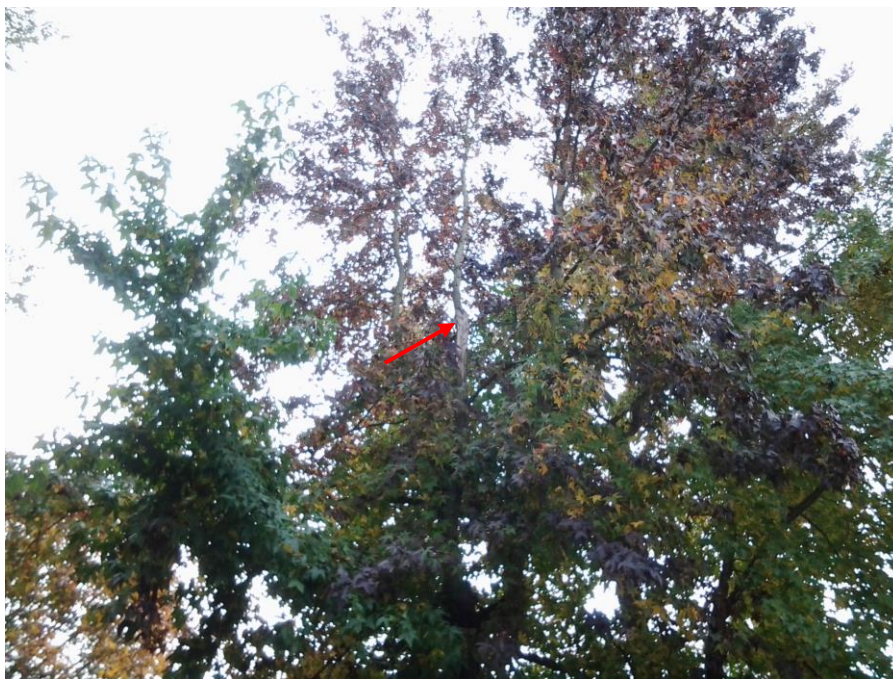
- 47) (Listed in first section)
- 48) Sweetgum tree with a 13.5" DSH, 50' tall, 14' spread in poor structural condition. It stands 10' north and 5' west of the NE corner of the building south of the subject property. Its color is decent and there is good new growth but it has a large caliper breakout point mid canopy on the north side (Figure 23).

The trees which have characteristics of branch failure include the #27-29 cottonwood, the #48, #49, and #63 sweetgums, and the #52, #55-57, and #60 Moraine locusts. All of these trees have probable **likelihoods of branch failure**. Branches from the cottonwoods have a **low likelihood** of hitting someone using the walking trail. This makes these trees **unlikely** to fail and impact. Even though the consequences of limb drop for the cottonwood would be **severe** if it struck someone, as it is unlikely to occur they are overall **low risk** trees. Branches from the sweetgums and locusts on the other hand hang over the parking which is used consistently for long periods of time so they are placed in the **high likelihood** category. The consequences of limb drop for the sweetgums and locusts would be **minor** making them **moderate risk** trees.

Figure 23. Photo of the #48 sweetgum looking up and to the south. Note the large breakout point in the mid upper canopy (red arrow).

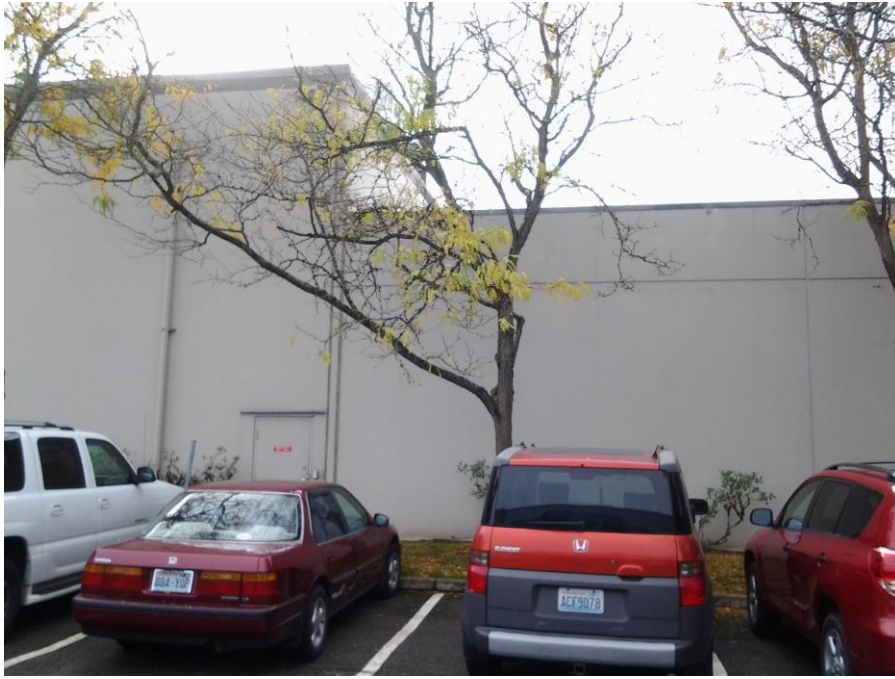
- 56) Moraine locust 8" DSH, 40' tall, 16' spread standing 20' west of the #55 tree. It is in fair condition. It has a low hanging large caliper branch which extends over the parking area as shown in Figure 24.

Figure 24. Photo of the #56 Moraine locust looking to the south. Note the low branch extending over the parked cars.

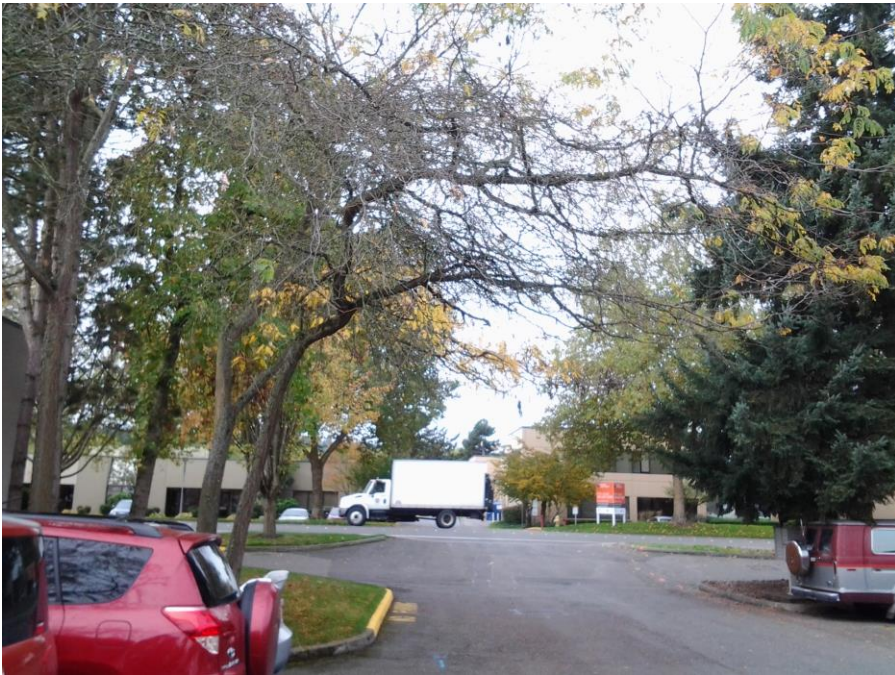
- 60) Moraine locust 10.5" DSH, 40' tall, 18' spread all to the NW over the drive as shown in Figure 25. It is standing 8' west of the #59 tree and is in fair condition.

Figure 25. Photo of the #60 Moraine locust looking to the west. Note how low and how far over the driveway its canopy stands.
